Report regarding Copper Beech tree at St John the Baptist Churchyard, Bath Road, Frome, Somerset BA11 1PL

Date Of visit: 13/06/16

Author: P Weaver (Corporate Health and Safety Advisor, Mendip DC)

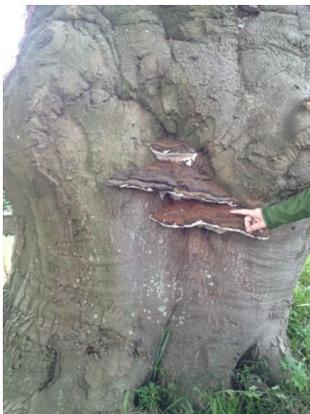
Figure 1 Fruiting structures on external trunk

explaining how the fungus (*Ganoderma sp.*) had affected the tree. The fruiting structures of the fungus on the external trunk surface (See figure 1) are the visible part of a more insidious condition which is causing extensive heartwood decay, effectively weakening the integrity of the load bearing trunk of the tree.

External specialists had been engaged to assess and monitor the internal density of the tree, over a period of time, and their results indicate that the decay of the supporting lignin is progressing.

The Tree Officer (Planning) MDC and The Tree Manager TLG agreed that nothing can be done to save the tree and that the continuing decay would inevitably result in the trunk being unable to support weight of the substantial canopy, causing the tree to collapse.

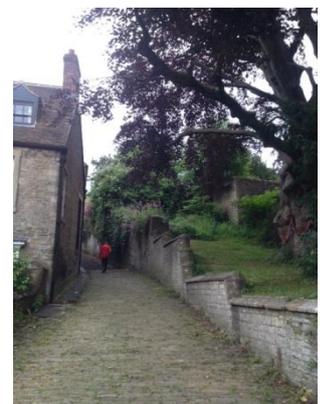
The tree is positioned adjacent to the boundary of the churchyard overhanging a pedestrian pathway which serves the local primary school. (See Figure 2)

This pathway joins another pedestrian path which runs at 90° parallel to the church, again within the shadow of the tree.

The tree has a substantial crown and a number of heavy limbs which could cause serious injury or possibly fatality if they were to fall onto a person.

Figure 2 Position of tree. overhanging pathway

Due to its position the felling of the tree must be carefully planned to ensure that it is carried out in a safe and controlled manner.
